INDOOR AIR QUALITY ASSESSMENT

**City Hall Annex/CATA Building
3 Pond Road
Gloucester, Massachusetts**

Prepared by:
Massachusetts Department of Public Health
Center for Environmental Health
Emergency Response/Indoor Air Quality Program
March 2006

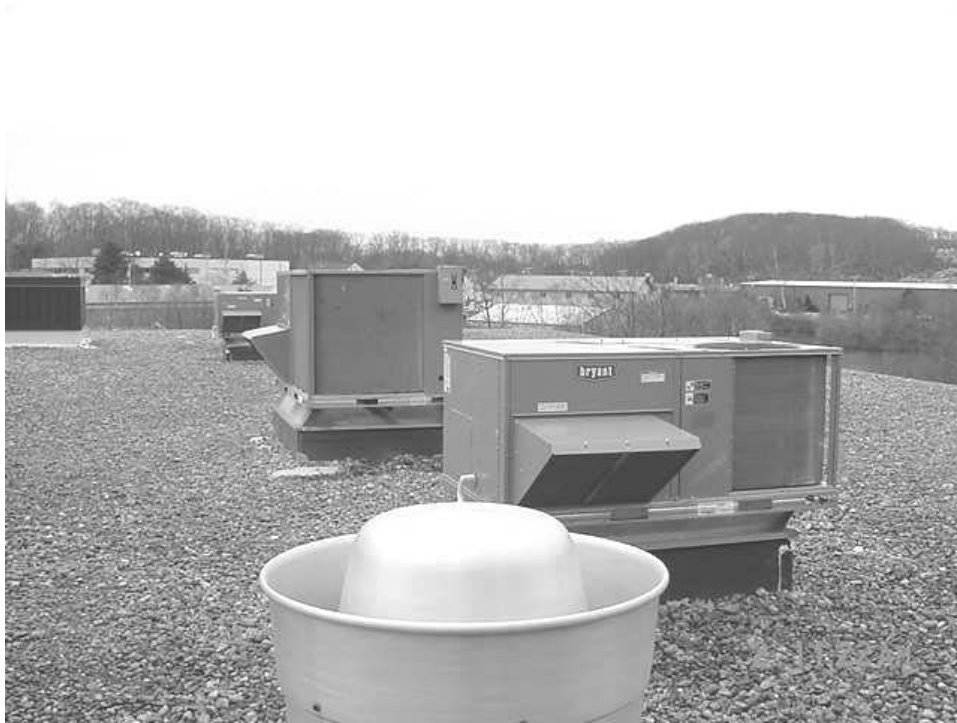
Picture 1

It can be seen from Table 1 that carbon dioxide levels were below 800 parts per million (ppm) in all areas surveyed, indicating adequate air exchange. The heating, ventilating and air conditioning (HVAC) system consists of rooftop air handling units (AHUs) (Picture 1) equipped with high efficiency pleated air filters (Picture 2). Conditioned outside air is provided through ducted ceiling vents (Picture 3). Air is drawn into the ceiling plenum via spaces around lighting fixtures and returned to the AHUs by return grates located in the ceiling tile system (Pictures 4). This system was operating throughout the building during the assessment; however, missing/damaged ceiling tiles

Rooftop Air Handling Units

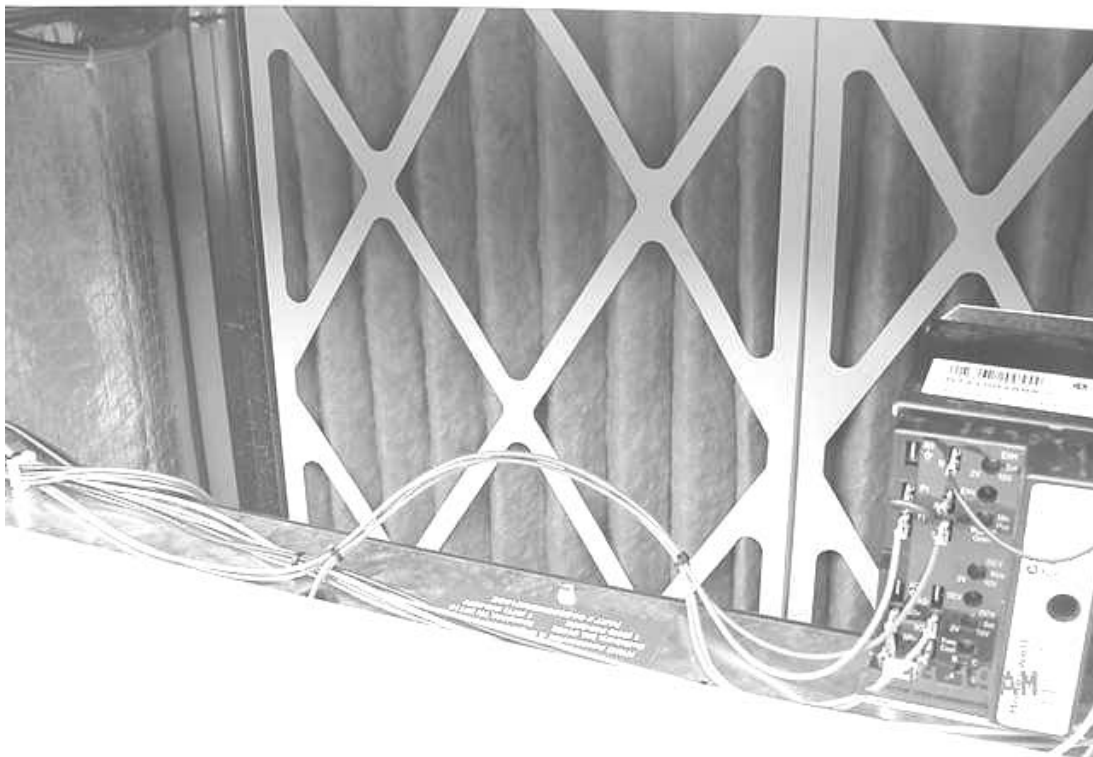
Picture 2

High Efficiency Pleated Air Filters in AHUs

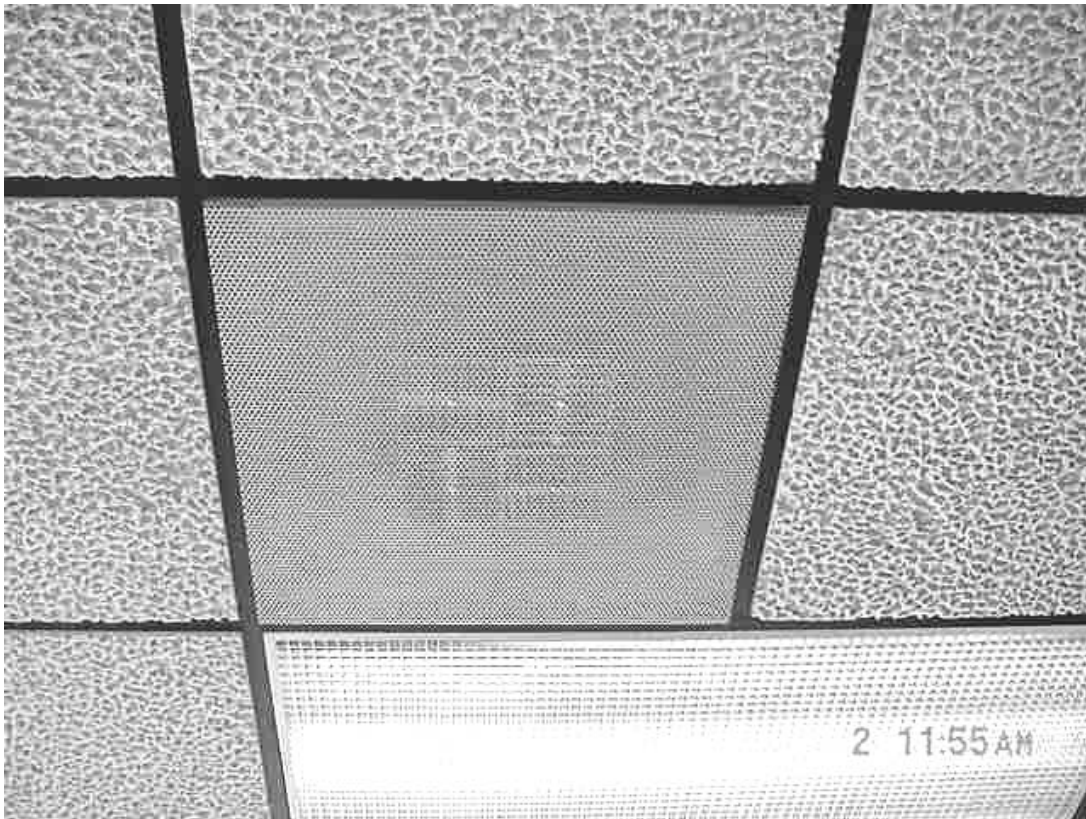
Picture 3

Multi-Directional Supply Air Diffuser

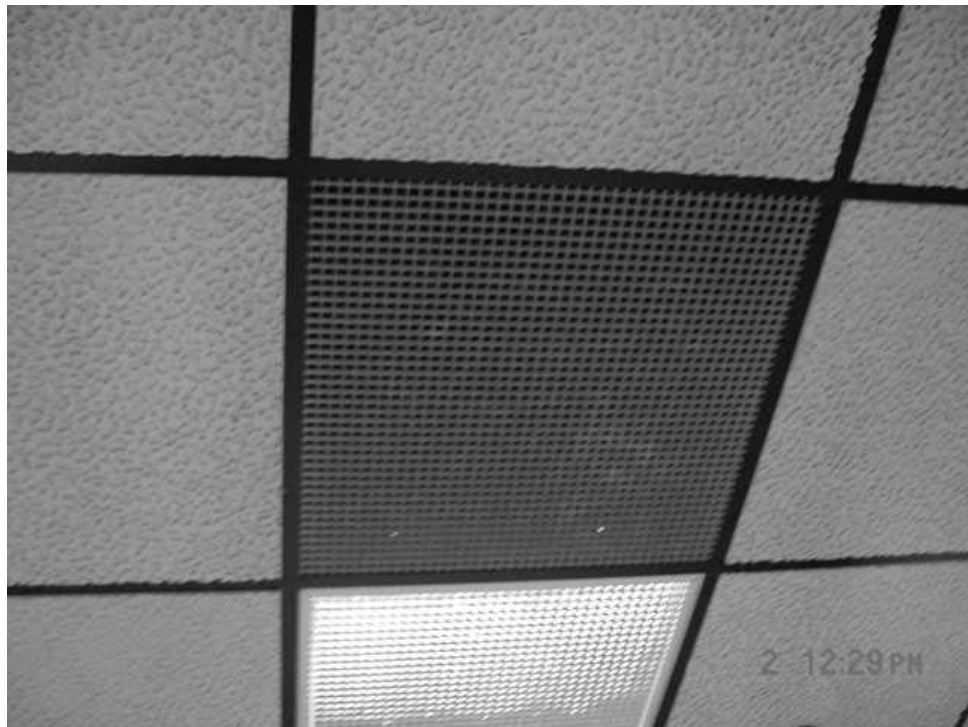
Picture 4

Ceiling-Mounted Return Grate

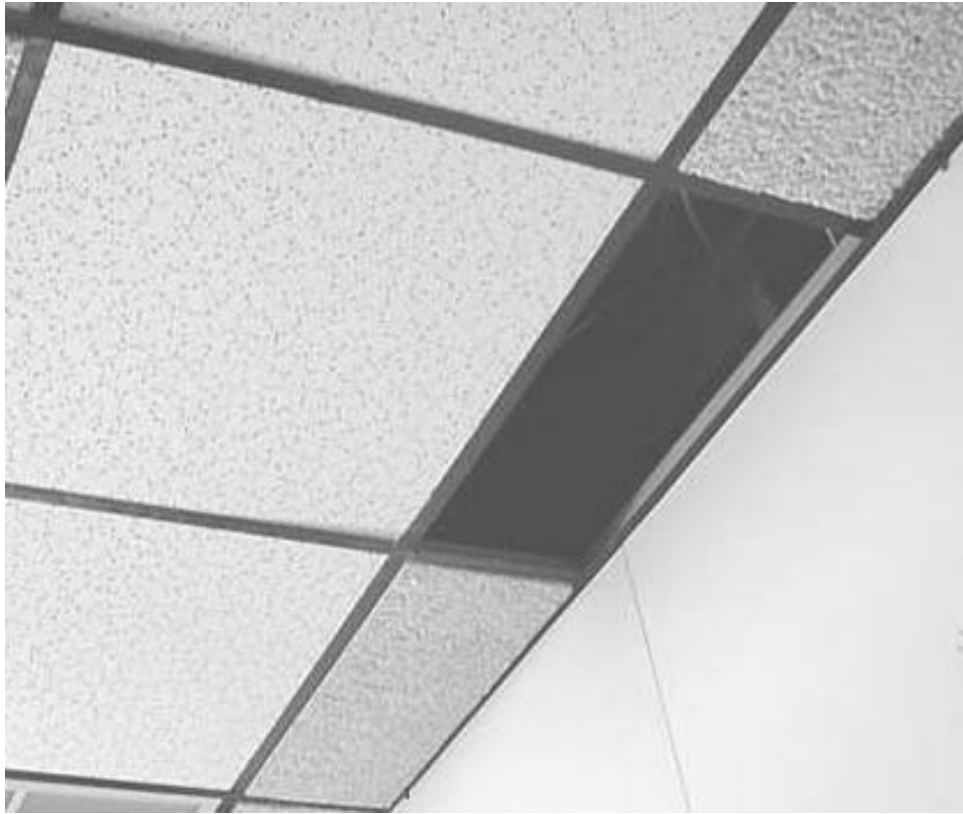
Picture 5

were observed in a few areas (Pictures 5 and 6). Ceiling tile systems must be intact to maintain the integrity of the ceiling plenum to provide exhaust ventilation.

Missing Ceiling Tile

1. Continue working with HVAC vendor to balance the ventilation system.
Ventilation industrial standards recommend that mechanical ventilation systems be balanced every five years (SMACNA, 1994).
2. Replace missing/damaged tiles to maintain integrity of the ceiling exhaust/return plenum.
3. Consider the following steps if vehicle exhaust entrainment becomes a persistent problem in the engineering area:
 - Install charcoal-activated filters in rooftop AHUs to filter out or reduce vehicle exhaust odors.

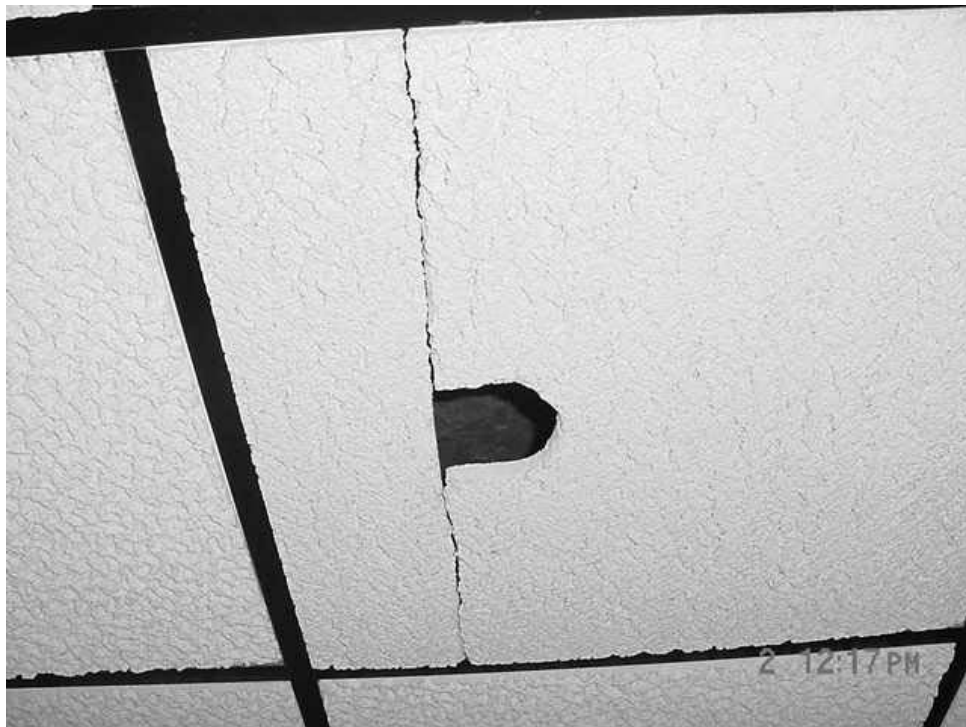
Picture 6

Hole in Ceiling Tile

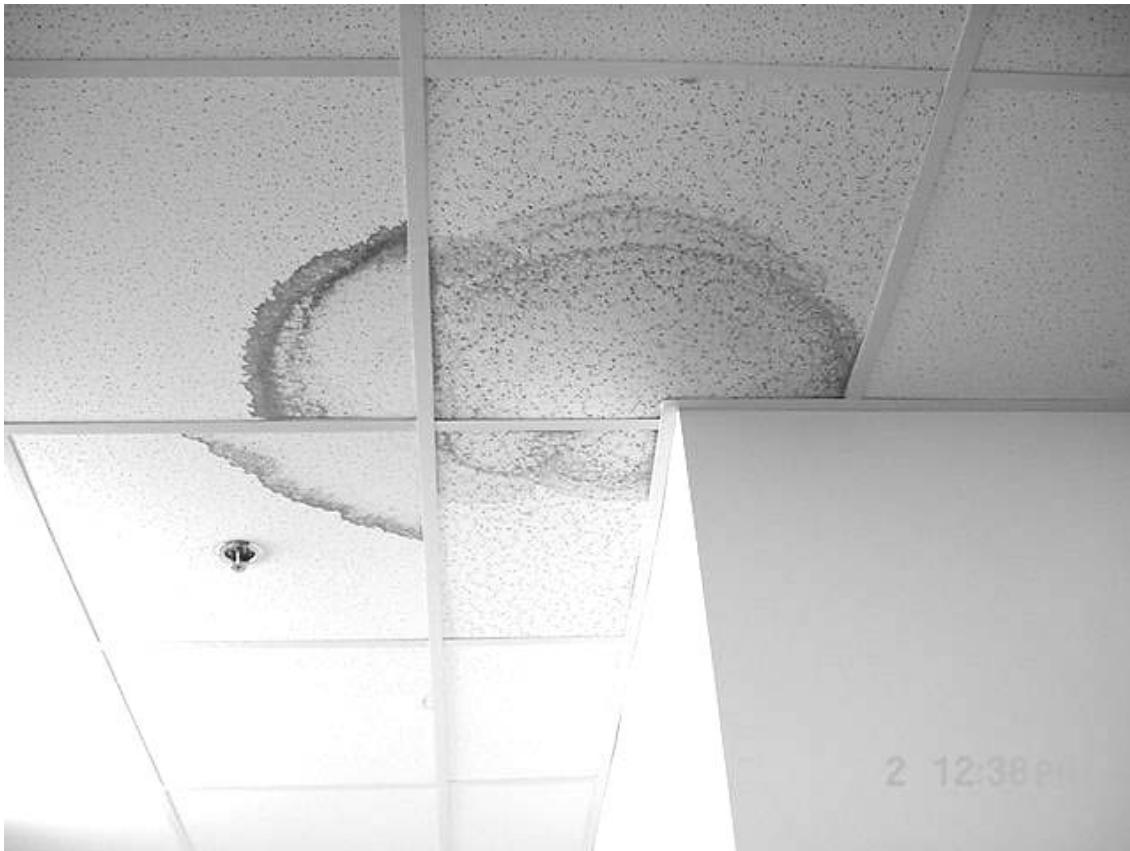
Picture 7

A few areas had water damaged ceiling tiles, most notably in the elevator lobby (Picture 7). Identification and elimination of water moistening building materials is necessary to control mold growth. In order for building materials to support mold growth, a source of water exposure is necessary. Occupants reported that ceiling tiles were damaged as a result of roof leaks that reportedly have since been repaired. Water damaged ceiling tiles can provide a source for mold growth and should be replaced after a leak is discovered and repaired. CEH staff removed ceiling tiles in a number of areas to examine conditions above the ceiling plenum. All areas appeared dry, and no visible mold growth and/or associated odors were observed/detected on the day of the assessment. In addition, CEH staff conducted moisture testing of water damaged ceiling tiles. Materials with increased moisture content *over normal* concentrations may indicate the possible presence of mold growth. All water damaged ceiling tiles tested were found to have low (i.e., normal) moisture content (Table 1) at the time of the assessment.

Water Damaged Ceiling Tiles in Elevator Lobby

5. Report any water leaks as they occur to building management for repair. Replace water damaged ceiling tiles and examine the areas above and behind these areas for mold growth. Disinfect areas of water leaks with an appropriate antimicrobial as needed.

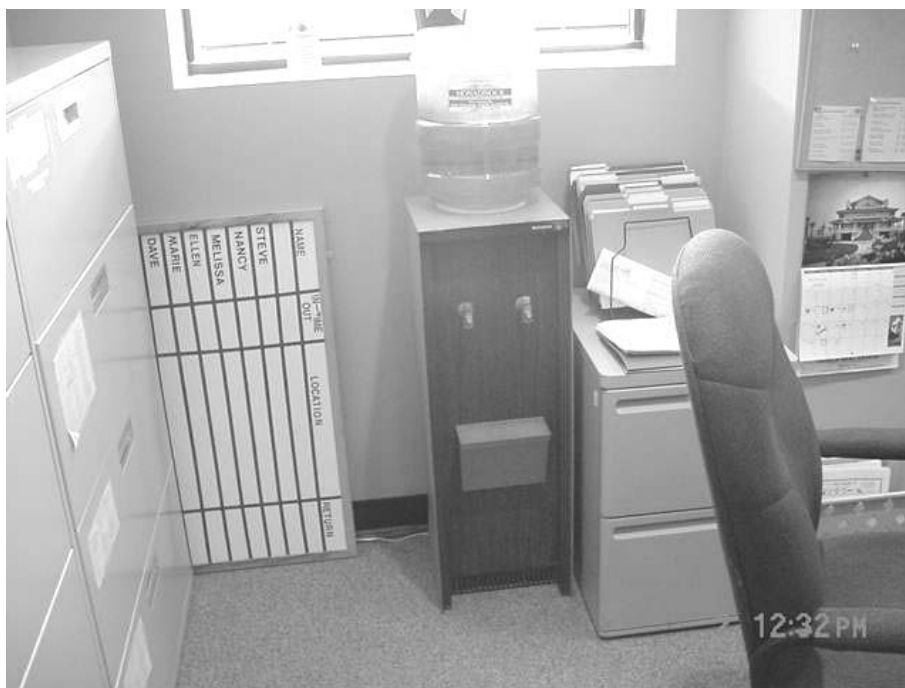
Picture 8

A water cooler was located over carpeting (Picture 8). Water spillage or overflow of cooler catch basins can result in the wetting of the carpet. In addition, the cooler had residue/build-up in the reservoir. These reservoirs are designed to catch excess water

during operation and should be emptied/cleaned regularly to prevent microbial and/or bacterial growth.

Water Cooler on Carpeting

6. Ensure plants have drip pans. Examine drip pans periodically for mold growth and disinfect with an appropriate antimicrobial where necessary.
 7. Relocate or place tile or rubber matting underneath water coolers in carpeted areas. Clean and disinfect reservoirs as needed to prevent microbial growth.

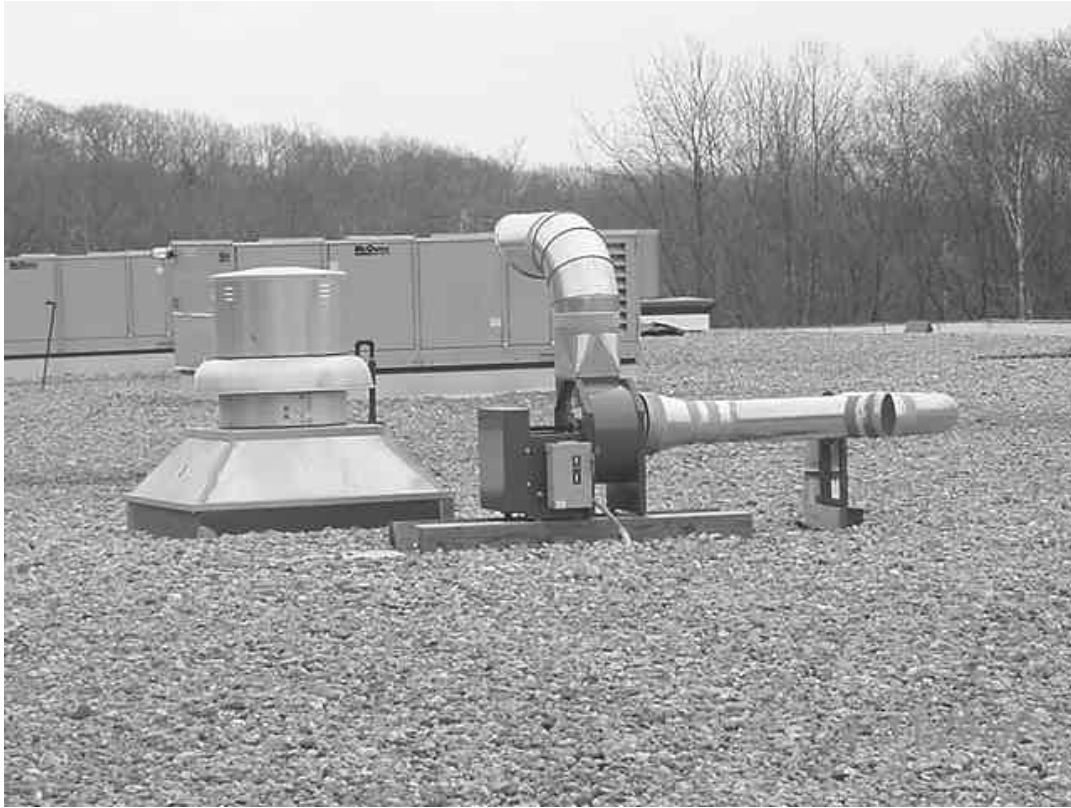
Picture 9

Some occupants expressed concern over the potential entrainment of exhaust emissions from the day to day vehicle operations of the CATA maintenance facility. The CATA maintenance facility is equipped with local exhaust ventilation that connects directly to the tailpipes of vehicles; vehicle exhaust is piped out to the roof through exhaust motors. Rooftop exhaust motors are ducted in a fashion that direct exhaust emissions *away* from the AHUs supplying air to GCHA office space (Picture 9).

Local Exhaust Motor on Roof of CATA Building Directing Exhaust Emissions *Away* From GTHA AHUs

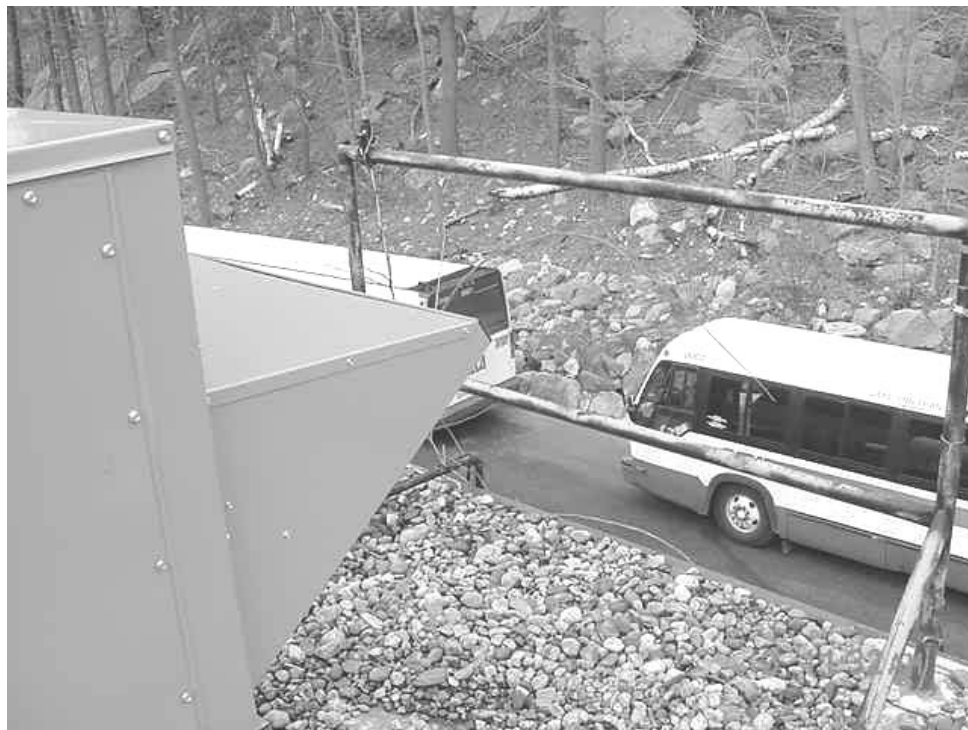
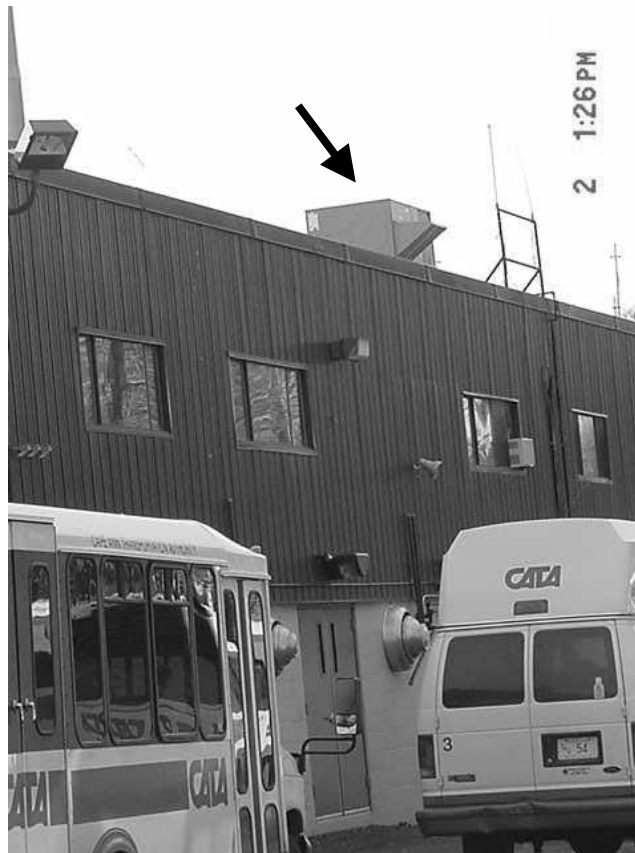
Although no complaints of exhaust odors were reported on the day of the MDPH assessment, the potential for entrainment exists. A more likely source for entrainment of exhaust emissions is from vehicles idling along the north side of the building. The AHU for the engineering department is situated on the roof along the edge of the north side of the building, with air intakes facing the area where busses and other CATA vehicles park (Pictures 10 and 11). These air intakes can draw in odors from idling vehicles.

Orientation of Engineering Dept. Air Intake to CATA Vehicles Parked along the North Side of Building

- Relocate (or re-duct) the intake for the engineering department AHU to the opposite side, away from areas of heavy vehicle traffic (idling) if complaints persist.

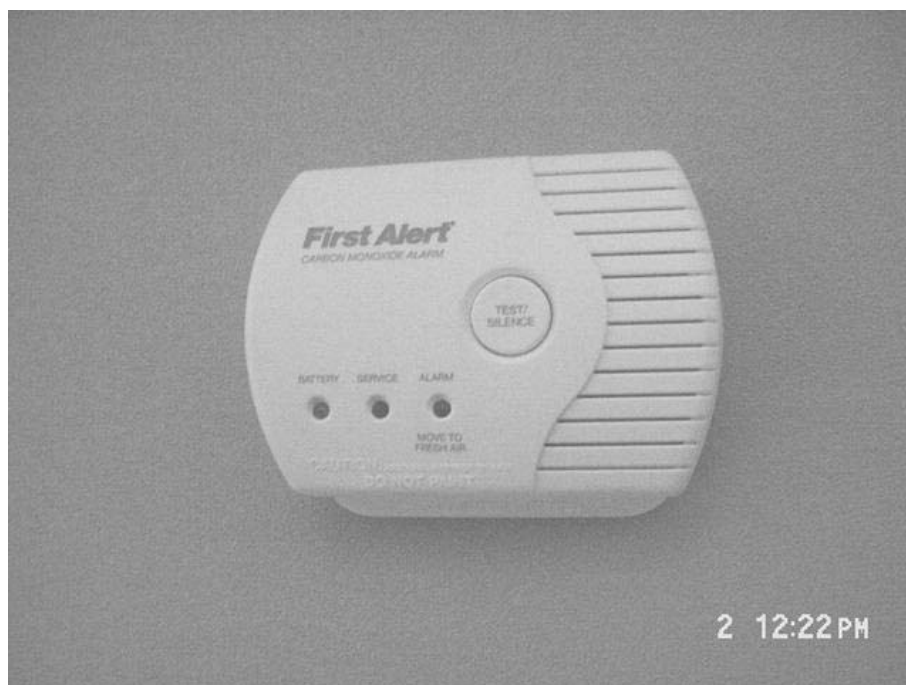
Picture 12

As a precaution GCHA employees have mounted a carbon monoxide monitor on an interior wall (Picture 12). According to the manufacturer's website, carbon monoxide alarms should be replaced every 5 years. Batteries should be monitored and replaced as needed to ensure proper working order (First Alert, 2006).

Wall-Mounted Carbon Monoxide Detector

10. Seal holes in men's and women's restrooms to prevent exposure to fiberglass insulation.
11. Replace carbon monoxide detectors every 5 years, replace batteries and test to ensure proper working order as per the manufacture's recommendations.
12. Refer to resource manuals and other related indoor air quality documents for further building-wide evaluations and advice on maintaining public buildings. Copies of these materials are located on the MDPH website: http://mass.gov/dph/indoor_air.

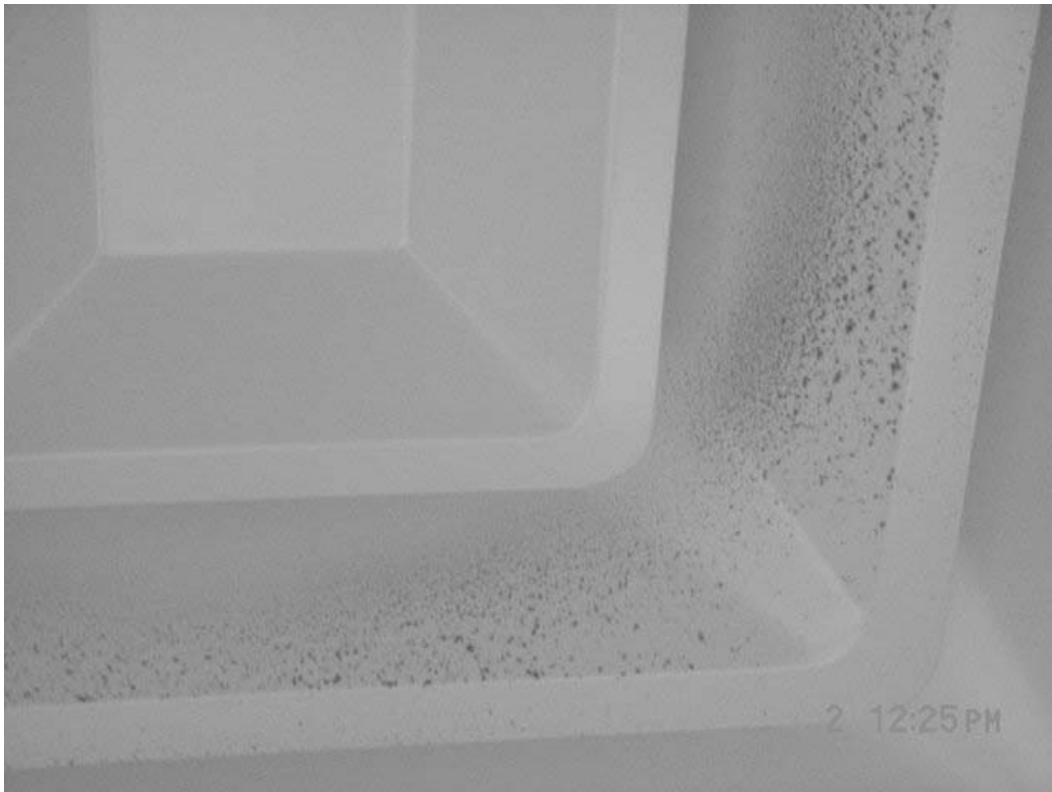
Picture 13

Building occupants reported dryness, respiratory and eye irritation. There are a number of inter-related issues that can contribute to this complaint. A possible source of irritants is the accumulation of dust on flat surfaces throughout the space. Dust can be irritating to the eyes, nose and respiratory tract. The large amount of flat surfaces provides a means for dusts, dirt and other potential respiratory irritants to accumulate and become airborne.

Dust Accumulation on Supply Louvers

8. Remove grates and clean supply/return vents periodically of accumulated dust.
 9. Consider cleaning carpeting annually or semi-annually in soiled high traffic areas as per the recommendations of the Institute of Inspection, Cleaning and Restoration

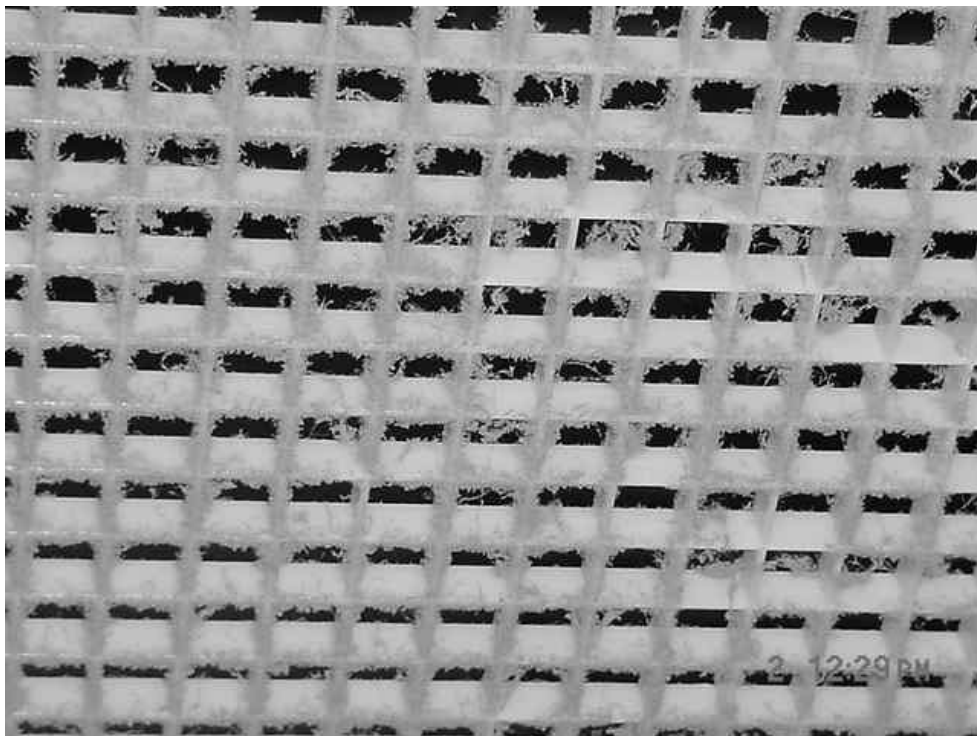
Picture 14

Dust Accumulation on Return Grate

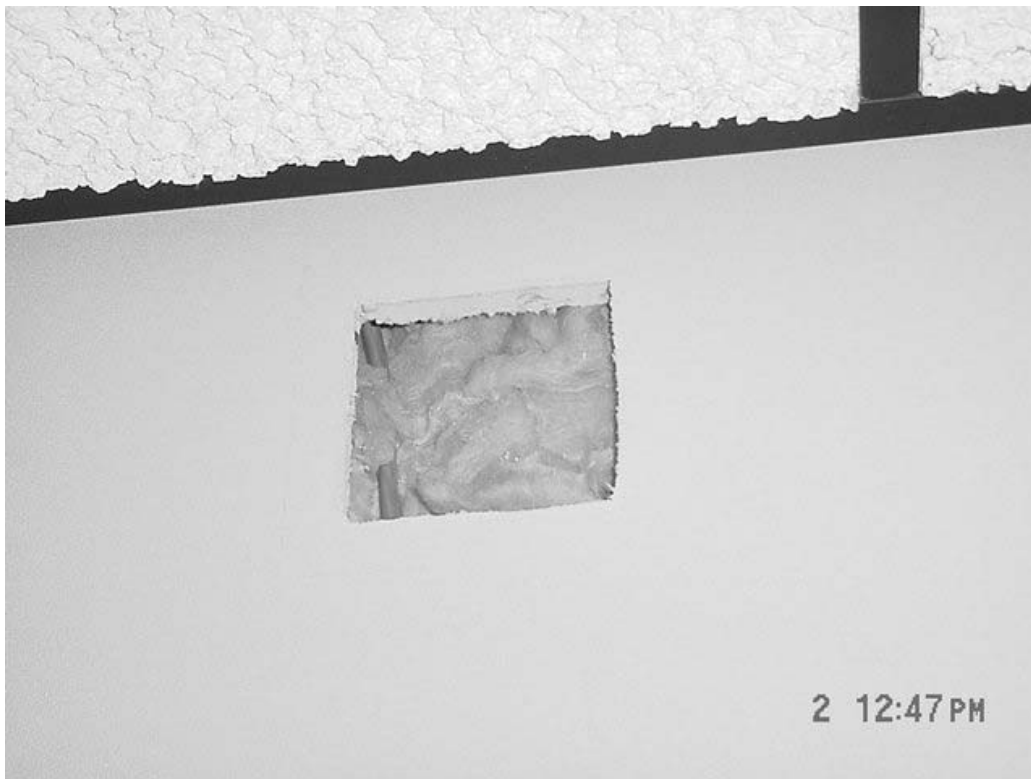
Picture 15

Lastly, holes were cut into walls in both the men's and women's restrooms, exposing fiberglass insulation (Picture 15). If work has been completed, these holes should be sealed. Fiberglass insulation can provide a source of skin, eye and respiratory irritation.

Hole in Restroom Wall Exposing Fiberglass Insulation
